Release Notes for MPiec controller firmware

Release 2.5.3 build 1

Patch for MP2300Siec and MP2310iec only

Released July 16, 2015.

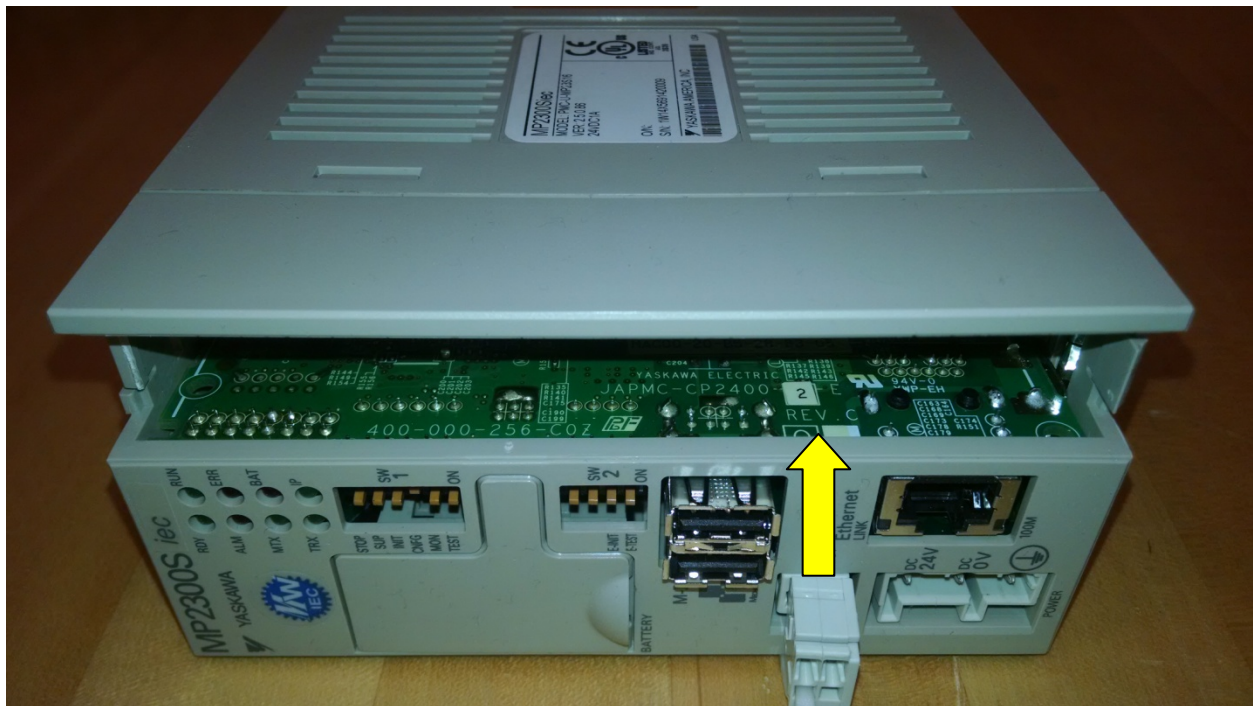
2.5.3.1 is a special release for the MP2300Siec and MP2310iec controllers with rev C hardware. To determine if the controller has rev C hardware, look at the silkscreen of the CPU board as shown below. If your machine was designed and tested using firmware 2.5.x firmware, Yaskawa recommends updating to 2.5.3.1 as the only difference is a change to eliminate the chance for impaired Ethernet performance as noted below.
