## FAQ# MTN-9DNLL5

**Question:** After receiving a “Data Area Settings Mismatch” warning when opening the project, compiling the project results in the error “Cannot compile resource file!” and three other compile errors. What causes this error and how is it fixed?

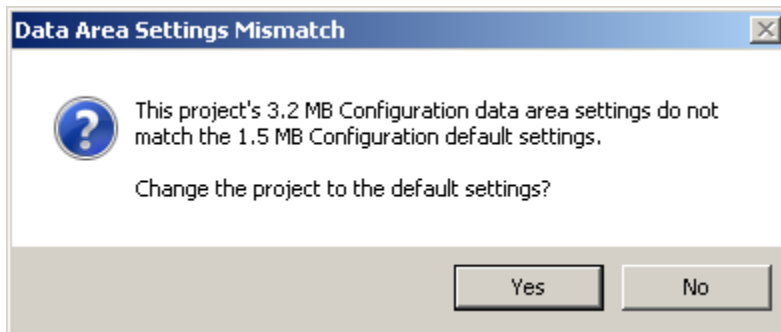
When opening or starting a new project, the following warning appears.

If these errors occur, open the “Change Default Data Area Settings” Menu

First select the controller type corresponding to project’s resource being used. When in the correct resource menu, select 1.5 MB Configuration and then click apply. After applying this configuration, the compile warning will not occur again.

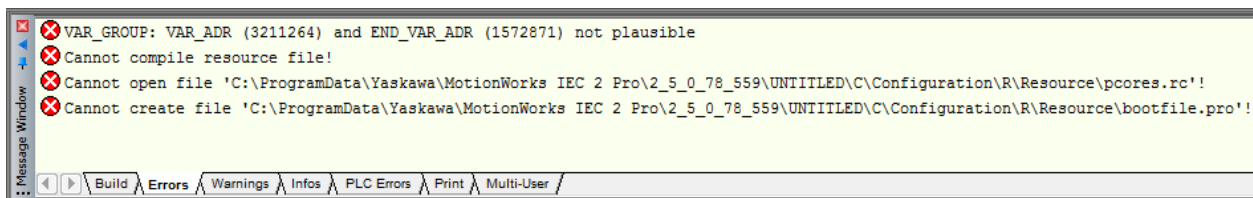
After clicking no and compiling the project, the following errors occur.
