Title: Why does Vipa remote I/O fail to update when it has a connection status of 0x1000 (connected) or 0x320 (deleted configuration)?

Product(s): Vipa

Doc. No. CNT-5KEKQI

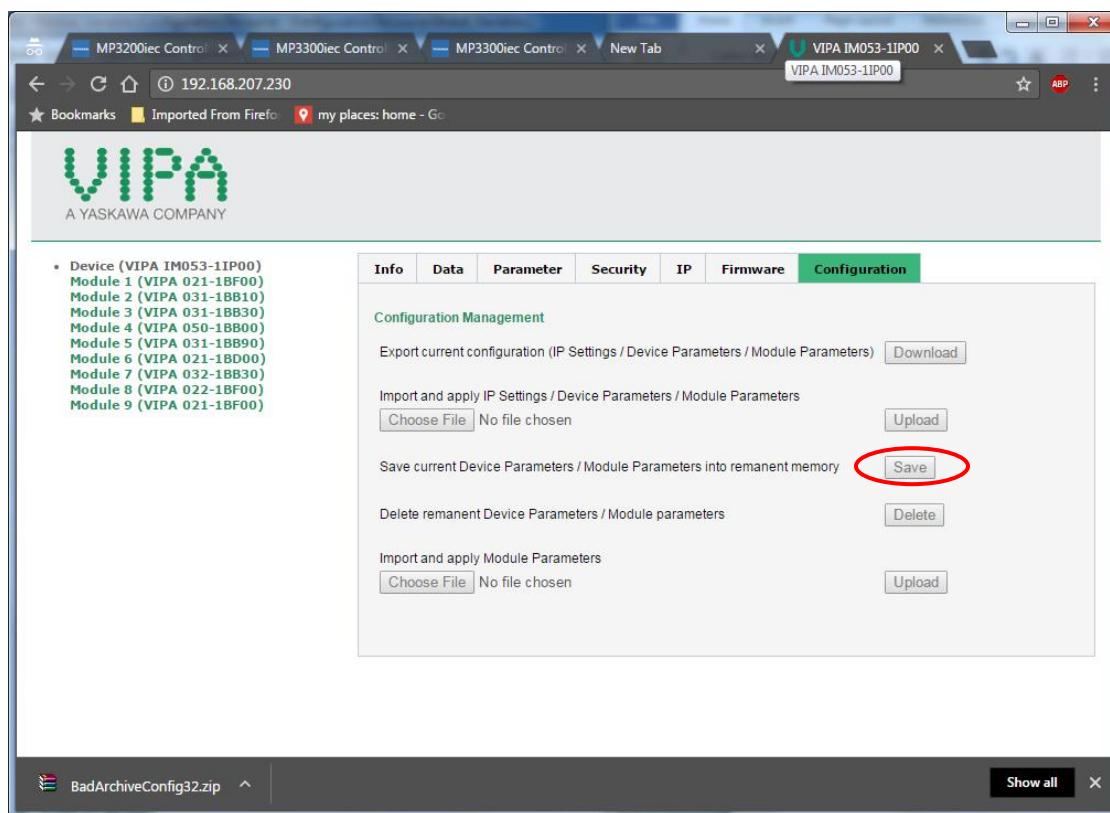
If the Vipa Ethernet coupler was previously configured and then modules are added or changed, you must perform an online save through its web page before they will function correctly. If the new configuration is not saved, the Vipa Ethernet coupler will flash the SF and MS red LED's when the controller connects. The I/O status variable in the MotionWorks IEC project will show a status of 0x1000 (connected) or 0x320 (deleted configuration) but the I/O will not update.

Navigate to the Configuration tab and press the Save button.

After saving the configuration, the Vipa Ethernet coupler must be powered down for at least 20 seconds, and then powered back up. If the power is short cycled, the Vipa Ethernet coupler will not power up.
