Here are several tips that may help resolve intermittent serial communication loss with Lonworks and the GPD506/P5:

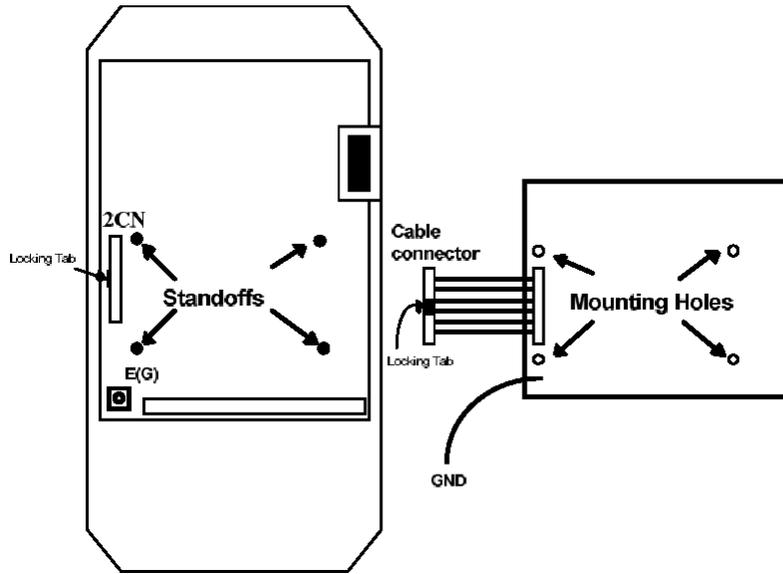
A) The Lonworks board is connected to the 2CN connector of drives control board by a 4 wire cable. Verify this cable is snapped in firmly to the 2CN connector. Also, make sure that the individual wires on the cable have not pulled out of their locations.

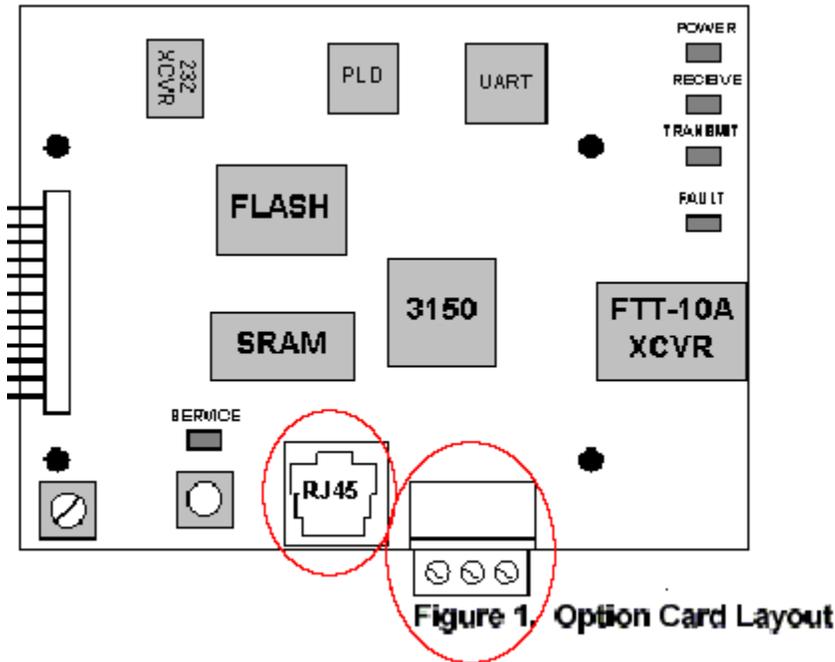
B) There are 2 connectors on the Lonworks board that allow for network communication from a building automation system. One is a 3 terminal green phoenix connector and the other, a RJ-45 plug. Verify the cables at these plugs are properly connected.

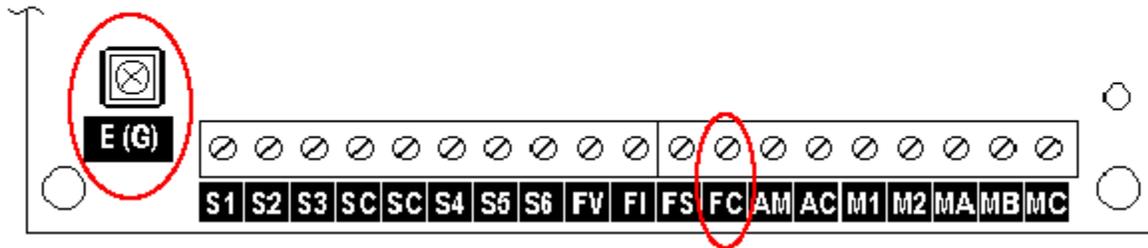
GPD506/P5 Control Terminals

Electrical noise causing interference with serial communication may be observed on the drive by using an oscilloscope.

Connect the positive and negative probe leads of the scope to terminals E (G) and FC, respectively, of control board.

Observe the wave form on the o-scope first. Then connect a .1uf 50VDC ceramic capacitor between the E (G) and FC terminals and observe the O-scope waveform again.

If a significant reduction in spurious waveforms are obtained , then the .1 uf capacitor may help filter noise levels that can affect network communication at the Lonworks board.
