Title: What causes an MPiec controller to post the "Duplicate LogicalInput IDs were detected" alarm?**Product(s):** MP3200iec, MP2300iec, MP2600iec,
MP3300iec, MotionWorks IEC**Doc. No.** PN.MPIEC.02**Product Overview**

Doc. No. PN.MPIEC.02

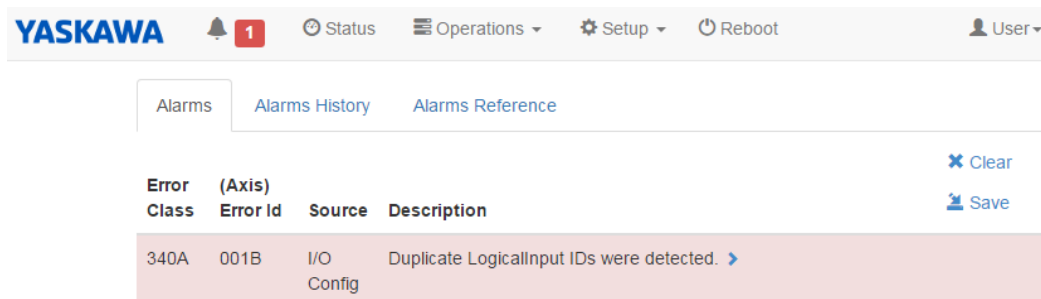
2. Verify under the Alarms tab that the 'Duplicate LogicalInput IDs were detected' alarm is present

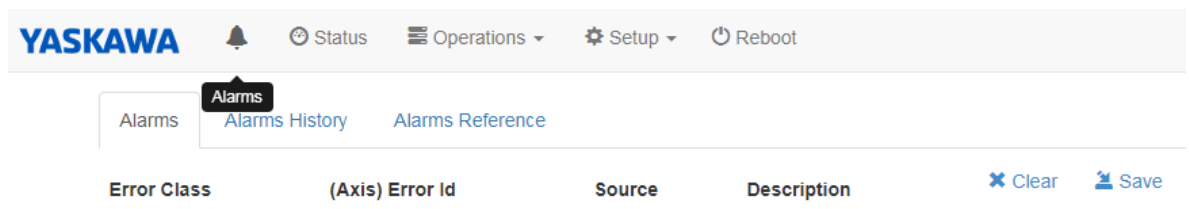
18. On the Alarms page, verify that the 'Duplicate LogicalInput IDs were detected' alarm is cleared
